# Manhole Inspection Summary

Manhole # S19M\_\_040MH

Insp Date: **2/24/08 2:01 PM**

**Location** Address: **2140 wilkens-christian alley**

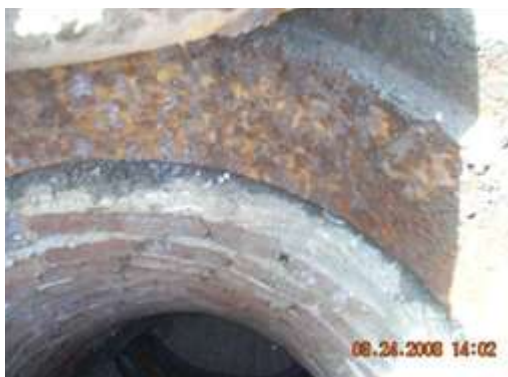
Defect 1

Offset: **1** (in.)

frame offset

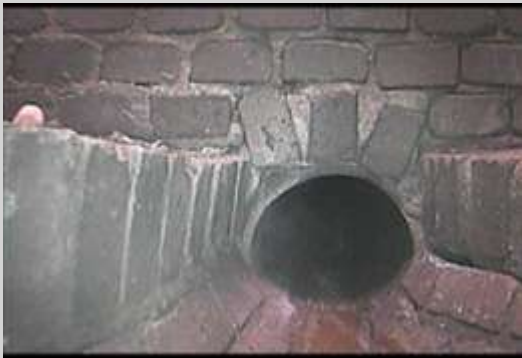
12 O'Clock Outflow

Pipe Height: **8.4** (in.) Rod and Bar (Angled)  
Pipe Material: **Clay** ☐ Pipe Lined  
Invert Depth: **8.17** (ft.) Flow Characteristics: **Slow**  
Deposits: ☒ None ☐ Mud ☐ Sludge ☐ Debris ☐ Grease  
Silt Depth: **0** (in.) Deposits Extent:  
Infiltration: **None** Pipe Seal Cond: **Sound**

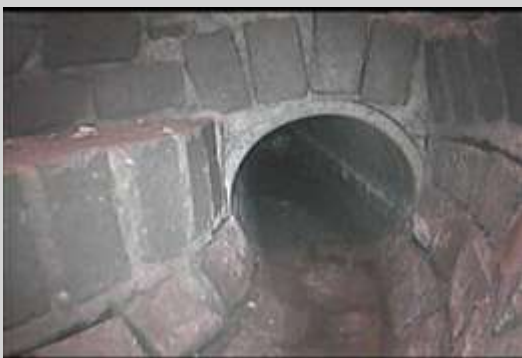
3 O'Clock Inflow

Pipe Height: **7.2** (in.) Rod and Bar (Angled)  
Pipe Material: **Clay** ☐ Pipe Lined  
Invert Depth: **8.02** (ft.) Flow Characteristics: **Slow**  
Deposits: ☒ None ☐ Mud ☐ Sludge ☐ Debris ☐ Grease  
Silt Depth: **0** (in.) Deposits Extent:  
Infiltration: **None** Pipe Seal Cond: **Sound**

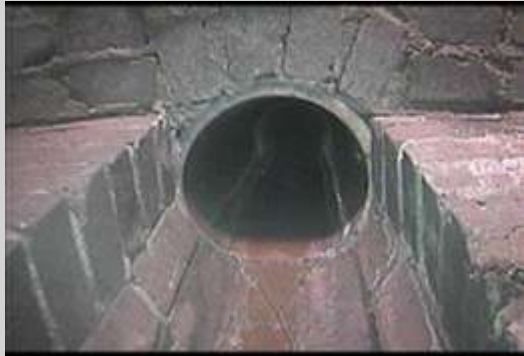
6 O'Clock Inflow

Pipe Height: **8.4** (in.) Rod and Bar (Angled)

Pipe Material: **Clay** ☐ Pipe Lined

Invert Depth: **7.76** (ft.) Flow Characteristics: **Slow**

Infiltration: **None** Pipe Seal Cond: **Sound**
